Pipeline inspection with thermal diagnostics

Introduction to the issue

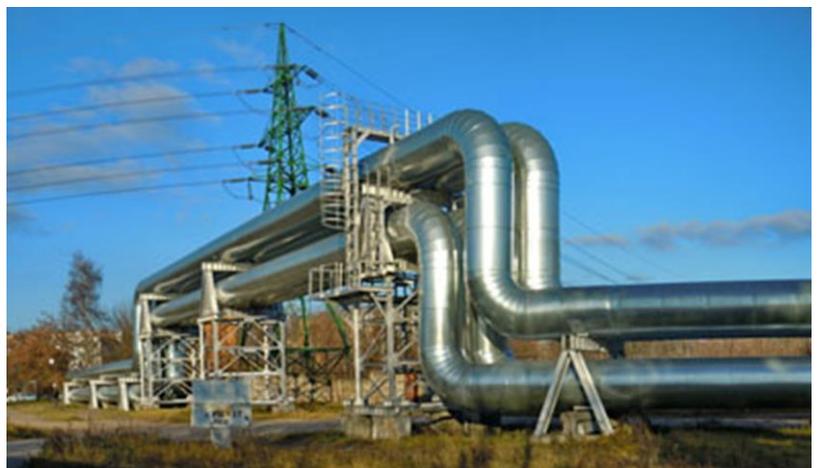
A pipeline is technological equipment that transfers heat used to heat residential and public buildings or whole towns.

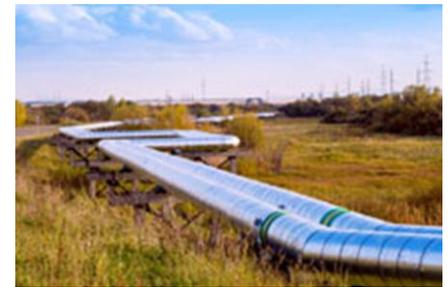
This hot-water pipeline appears to be fine during visual inspections. As we will mention later, there are many thermal bridges on this pipeline that reduce the efficiency of the transport of thermal energy. Traditional cameras do not detect defects on internal heat insulation and leaks below the surface of the ground.

Although in the visible spectrum this hot-water pipeline is completely without defects, the measurement of thermal camera shows that on the left hot-water pipeline there are a series of thermal bridges resulting in thermal losses.

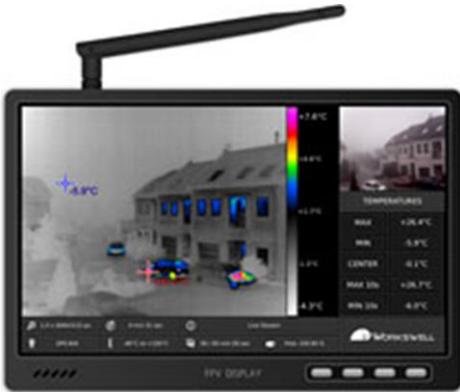
Workswell WIRIS can be fully controlled using a traditional RC controller from which all functions of the system are accessible. In addition to all functions, the monitor displays images from the thermal camera as well as the colour camera.

The Workswell WIRIS thermal imaging system for drones is designed for assembly on the drone (UAV). **The set is light, mobile and fully controlled using a standard RC controller.** The system combines two camera systems - **a camera for visible spectrum (for inspection of visible defects on the piping) and a thermal**

camera (for detecting hidden defects). The servicing software enables to **remotely switch camera regimes, to record radiometric videos and to make static images in the visible, as well as the infra-red spectrum.** The operator sees objects under the drone in real time or can analyse records to identify damaged areas.
