Thermodiagnostics of flat roofs

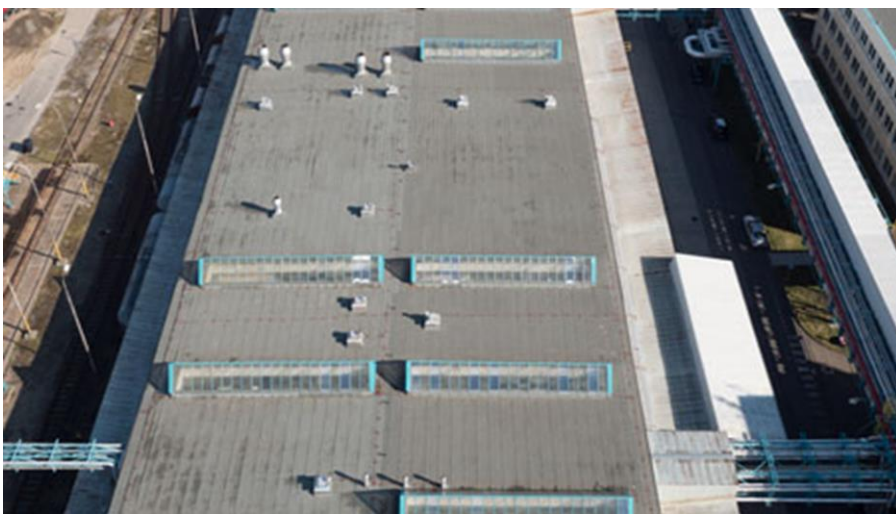
Flat roof with risk of rainfall retention and roof leaking.

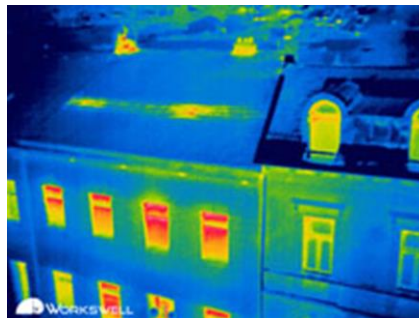
The thermal bridge on the roof of the building results in significant thermal losses.

During the heating season, the thermal camera can also identify areas that are poorly insulated (where what are known as thermal bridges have occurred) and where there are thermal escapes. These areas show as warmer than the surrounding parts of the roof.

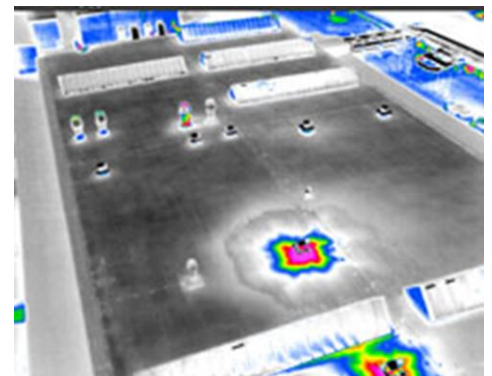
Areas affected by moisture are discovered via thermal differences identified by the WIRIS thermal imaging system located on the drone.

The physics behind the issue of thermal image inspection of problems related to the moisture is based on the fact that the dry part of the roof (not affected by moisture) is cooled and heated slower than the wet part of the roof insulation.

Thermal image inspection using a thermal camera during or after sunset (where the roof has been heated throughout the whole time) identifies the moist areas because the dry parts of the roof cool slower than the wet places, which have a higher thermal capacity.

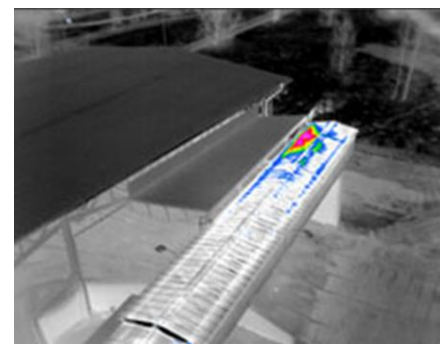
Checking the roof using a manual thermal camera would be very complicated, the roof is difficult to walk on. When using Workswell WIRIS, monitoring is fast and safe and it is possible to obtain an excellent overview of any problems.
