Thermodiagnostics in the power engineering sector

Introduction to the issue

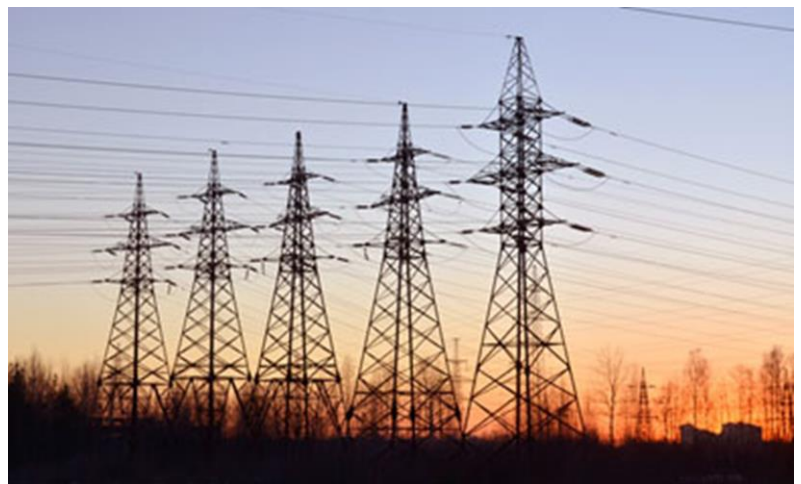
Columns and distribution lines for high voltage networks.

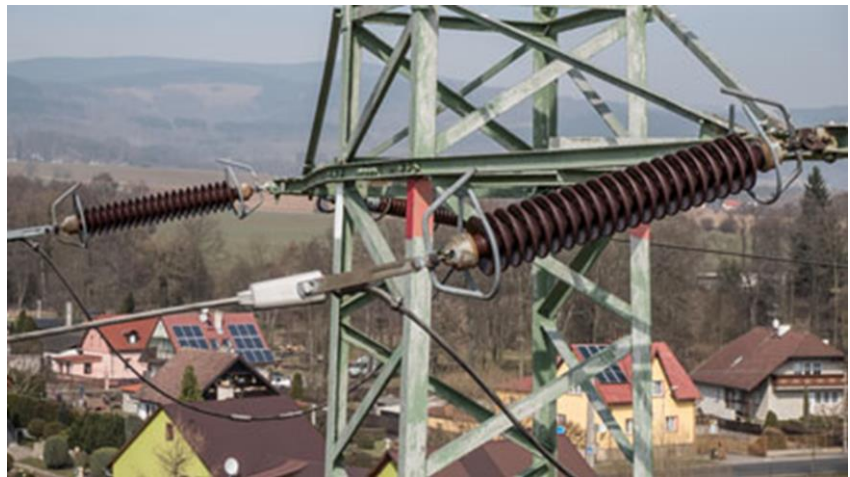
Joint on the high voltage distribution line. The place where a problem may occur, i.e. origination of transient resistance with consequent overheating.

One of the most frequent failures in the distribution network is the overheating of individual components due to transition resistance. Transition resistance occurs in imperfect places (damaged, outdated or unprofessionally installed) electric joints.

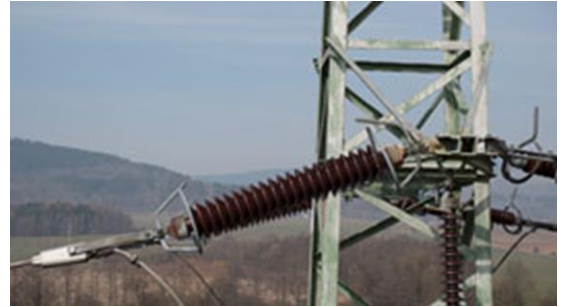
Photographic image from an aviation inspection of high-voltage distribution lines. Although there is nothing to be seen on the photo, there is a defect on the joint in the form of high transient resistance. The electric joint has become overheated and according to the recommendation in ISO 18434-1 should be repaired as soon as possible.

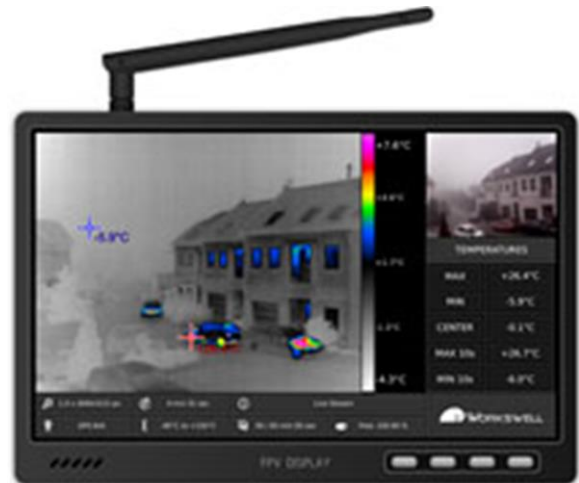
Workswell WIRIS can be fully controlled by a traditional RC controller from which all system functions can be accessed. In addition to all functions, the monitor displays images from the thermal camera as well as colour camera. Information is available about the measured temperature (min/max and central spot) during the flight.
